Titan Roof Restoration

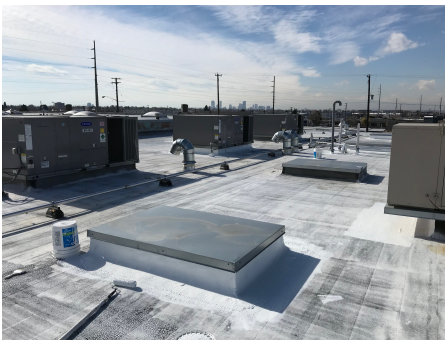
The roofing job consisted of multiple crews operating two coating rigs which worked simultaneously. “There were two or three teammates that helped move hoses and rolling out product and a ground man that operated the pumps and other equipment,” Bock explained.

With the applicators in place, the rest of the crew power washed the substrate using 2,500-3,500 psi washers to ensure proper surface preparation by cleaning and removing contaminants. From there, the Titan crew used a primer treatment over the existing single-ply membrane to ensure proper coating adhesion and act as a stain-blocking sealer before the final application of silicone.

Once the primer was applied, crew members prepared roof penetrations, along with other detail work, so the silicone coating applicators could work fast and efficiently.

The finishing touches involved areas of the roof with rooftop equipment, such as HVAC units, where maintenance personnel might walk more frequently than most other areas. “For those particular areas, we did an additional layer of silicone with a safety-yellow aggregate finish,” Bock said. “It adds durability and slips resistance.”
